November 13, 2006

**Subject: Site Report for
 Brentwood Skatepark Mercury Response
 198 Griffith Lane
 Brentwood, California 94513-1963
 TDD #TO1-09-06-06-003**

Brentwood Skatepark Mercury Response

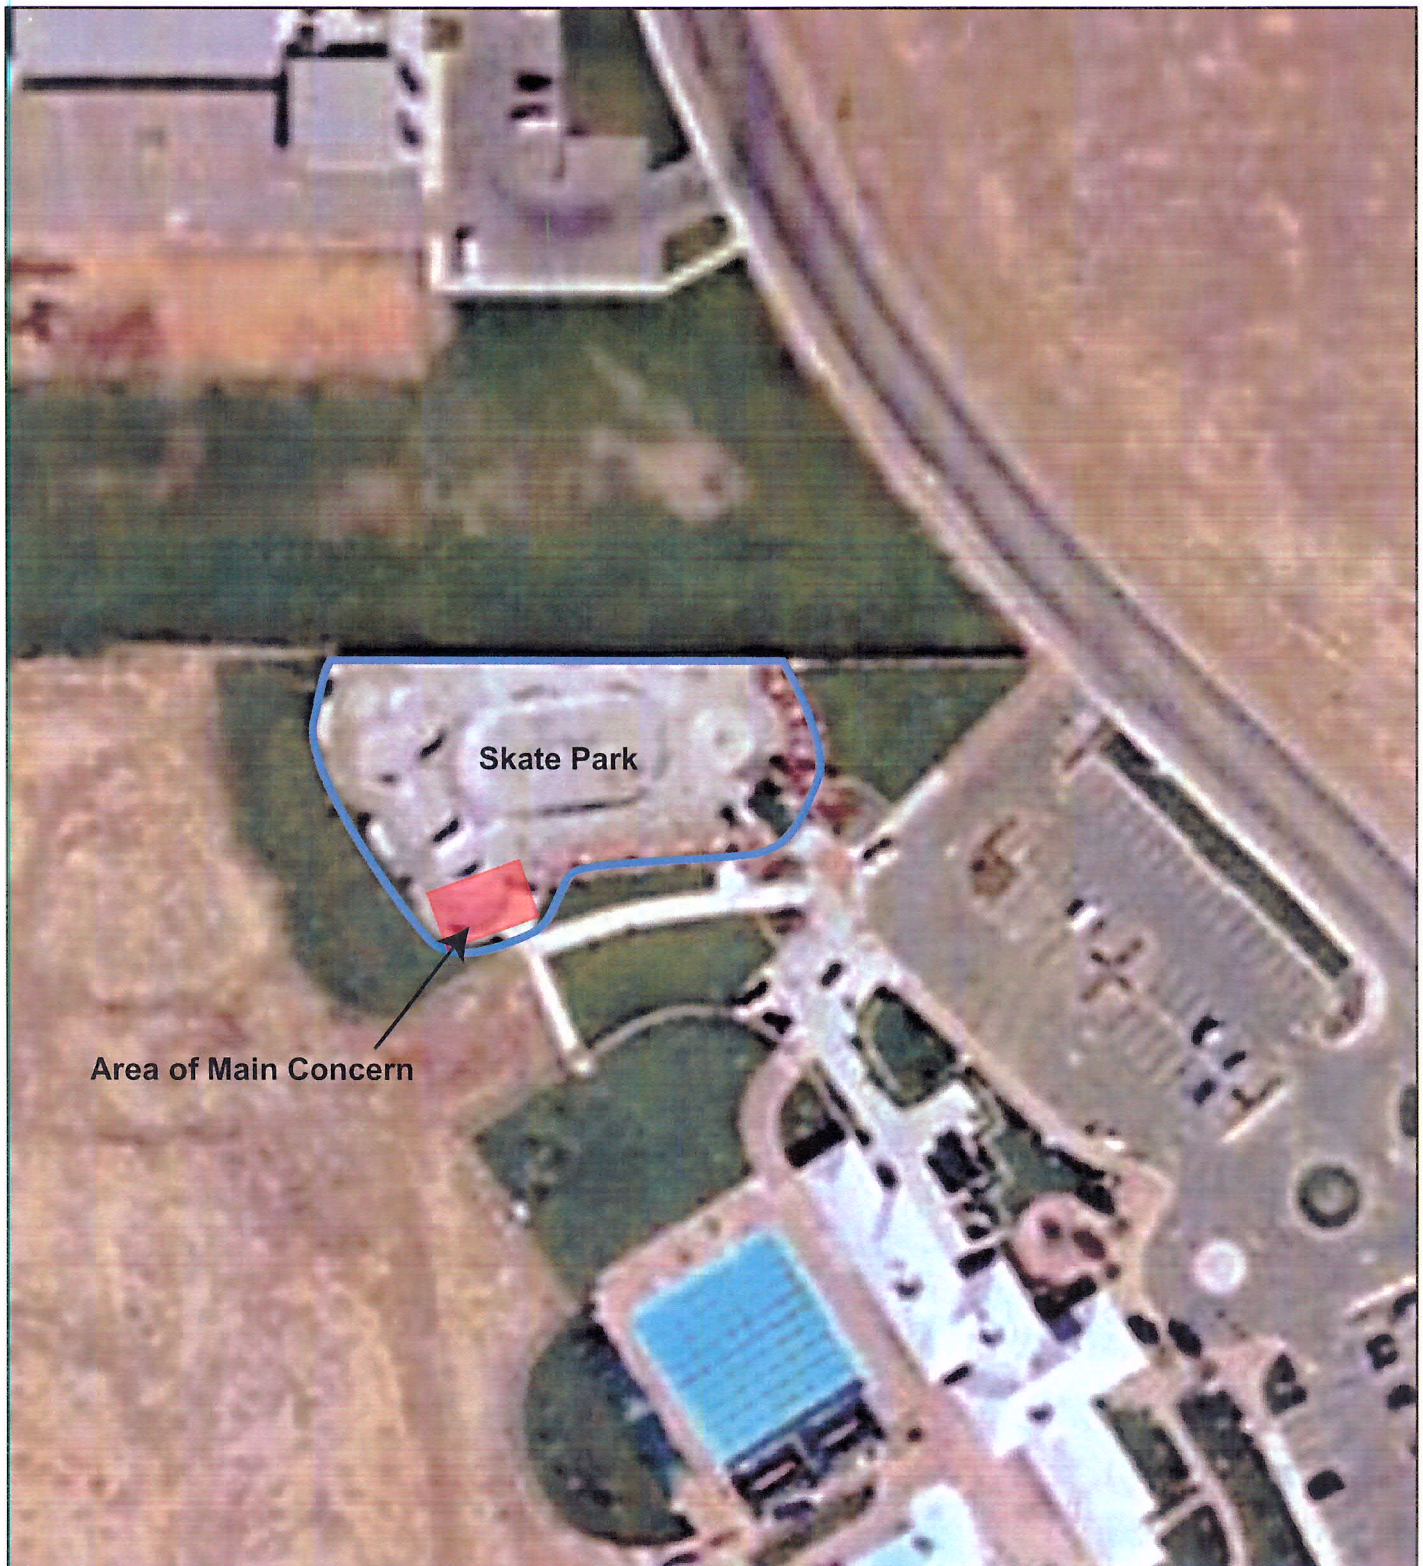
Figure 2

On October 23, 2006, Adam Palmer from the DTSC requested EPA ERS assistance with the assessment and cleanup of a small mercury spill at a skatepark in Brentwood, California. The city-managed park is located at 198 Griffith Lane, Brentwood, Contra Costa County. This location is a public recreation facility containing a park, two swimming pools, and a skatepark. The skatepark is comprised of concrete skating surfaces and bricked seating areas. The spill occurred within the southwestern portion of the fence-enclosed skatepark along a concrete banked turn area. The area of concern is illustrated on Figure 2.

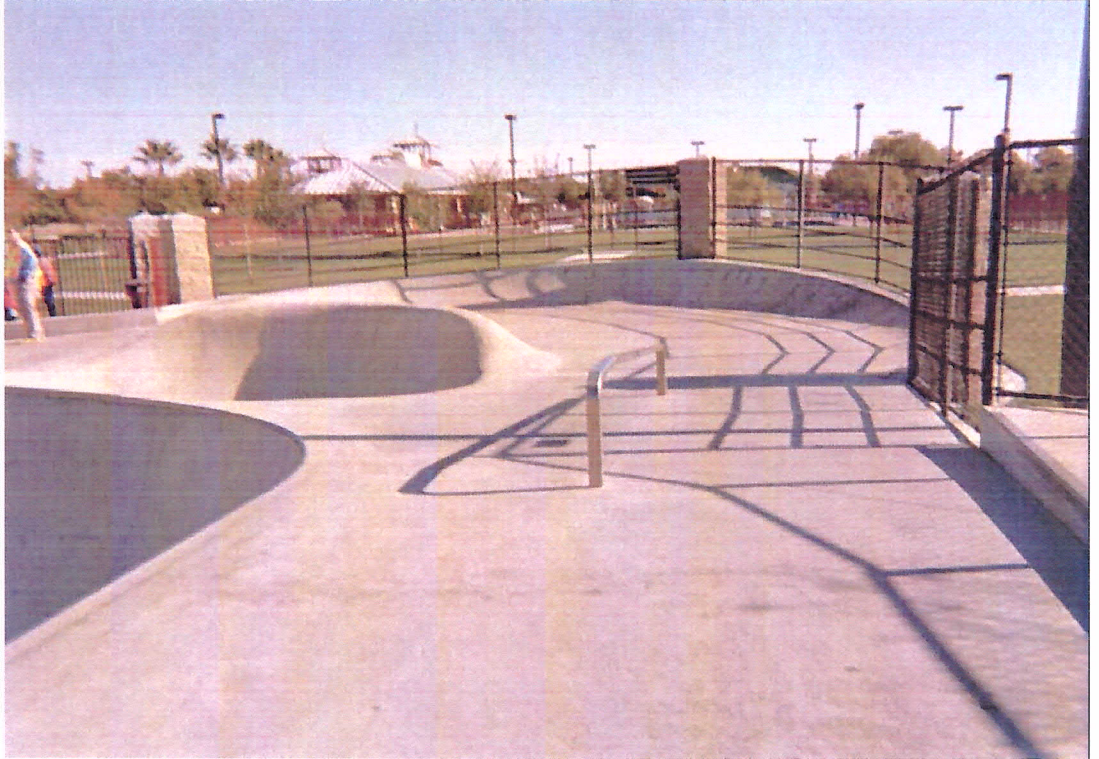
Photo No.
1

Image of Skatepark

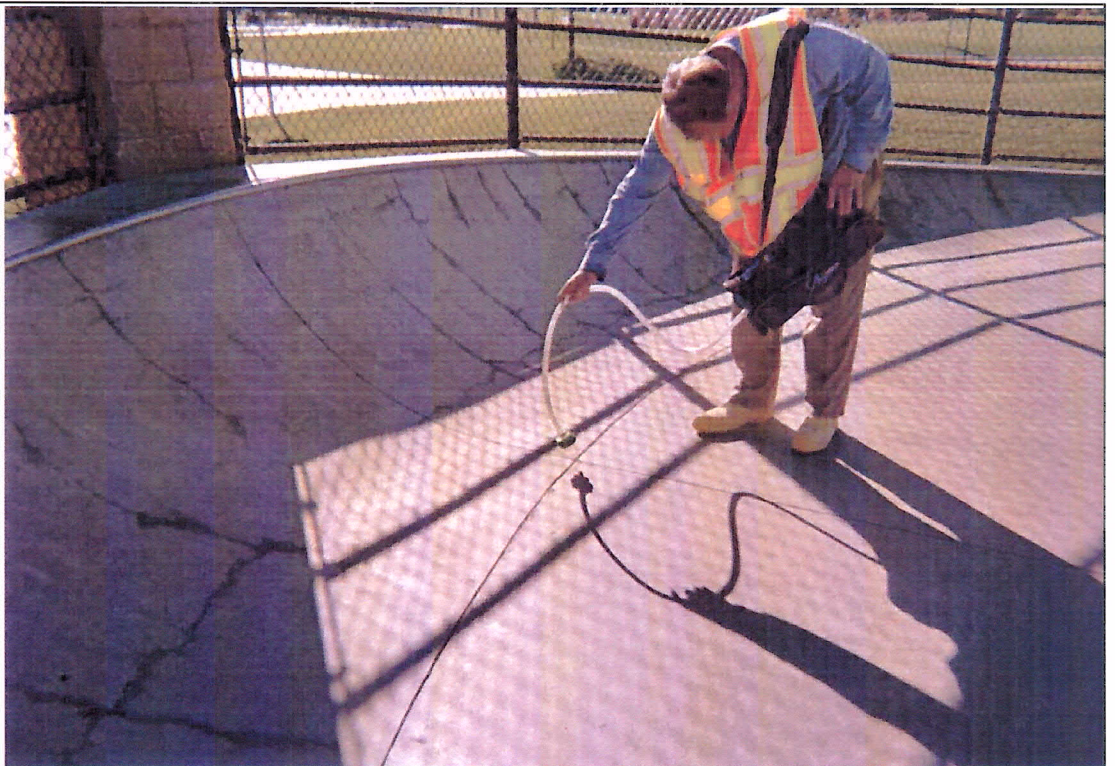
Photo No.
2

Following the initial health and safety survey, Team 9 was directed to assess the southwestern portion of the skatepark, where cleanup had occurred the previous day. The planning associated with the data collection effort is documented in the Brentwood Skatepark Emergency Response and Time Critical Quality Assurance Sampling Plan (ER-QASP) for Air Sampling. The initial survey and assessment surveys were performed in Level D following Team 9's Health and Safety Plan for the response. Mercury sampling was performed both at ground level (less than 2 inches ground surface) and within the breathing zones. Breathing zone readings were typically no higher than background range. Mercury vapor concentrations of approximately $200 \text{ ng}/\text{m}^3$ were noted at 2 feet above ground surface in the center of the banked turn area in the southwest portion of the skatepark. The center of the banked turn area was the reported location where the elemental mercury had been found and removed. The mercury vapor concentrations found were well below the Agency for Toxic Substances and Disease Registry (ATSDR) suggested action level for mercury of $1,000 \text{ ng}/\text{m}^3$ (Residential Occupancy Level). Air monitoring at the ground level suggested that mercury was still present in the seams between the concrete surfaces. Mercury vapor concentrations of up to $13,000 \text{ ng}/\text{m}^3$ were noted within the seams that ran through the middle of the banked turn area. Additionally, slightly elevated vapor concentrations

(600 to 13,000 ng/m³) were noted when monitored directly above other seams and cracks throughout the banked turn area.

Team 9 member Howard Edwards monitoring Area of Concern.

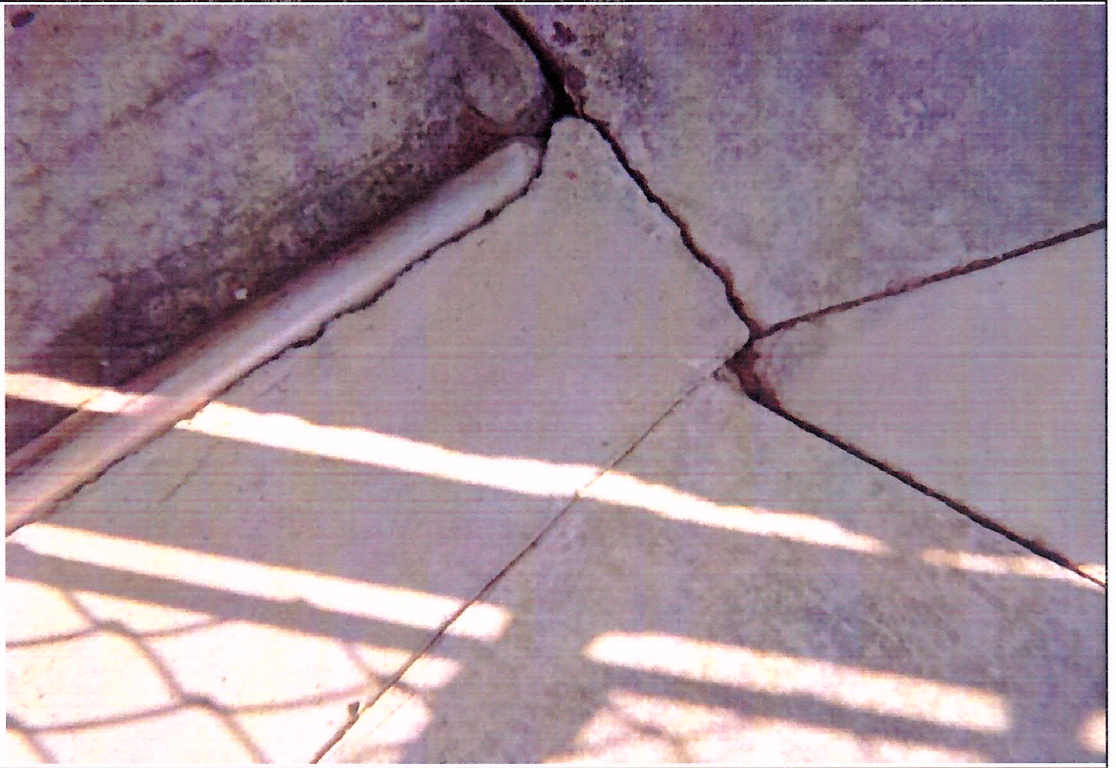
Photo No.
3

Example of seams within
skatepark cement.

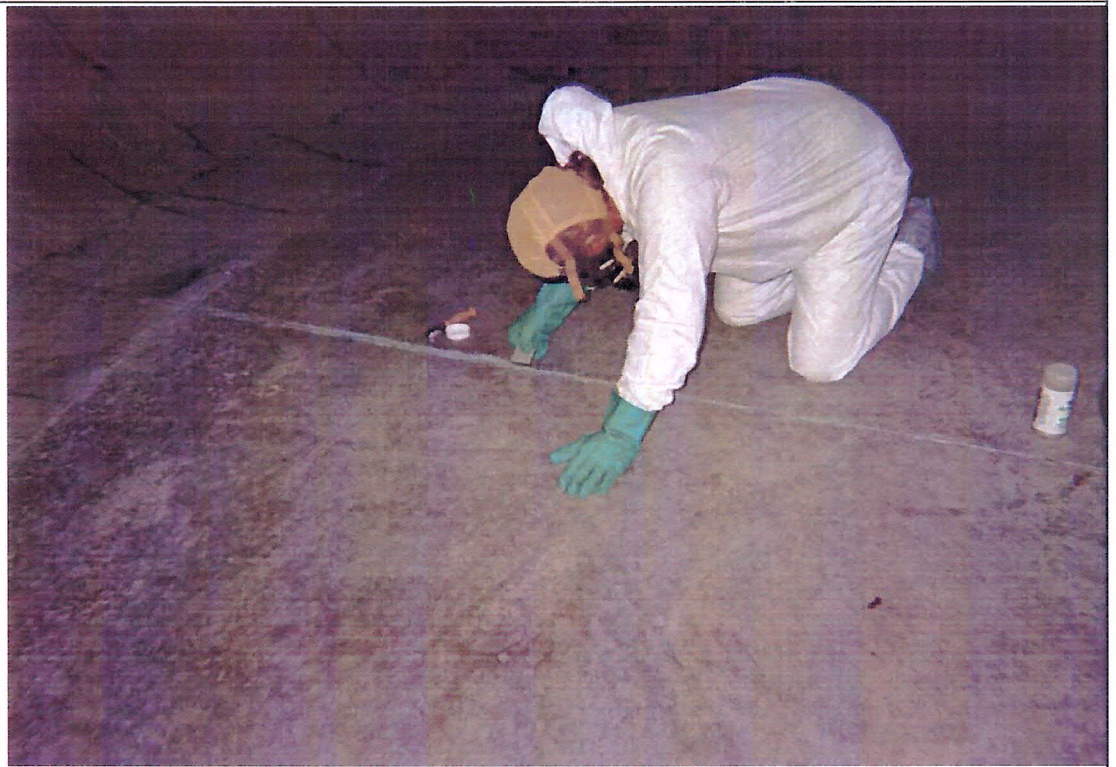
Photo No.
4

Contra Costa County
Hazmat Team member
using Hg-Absorb to
mitigate vapors.

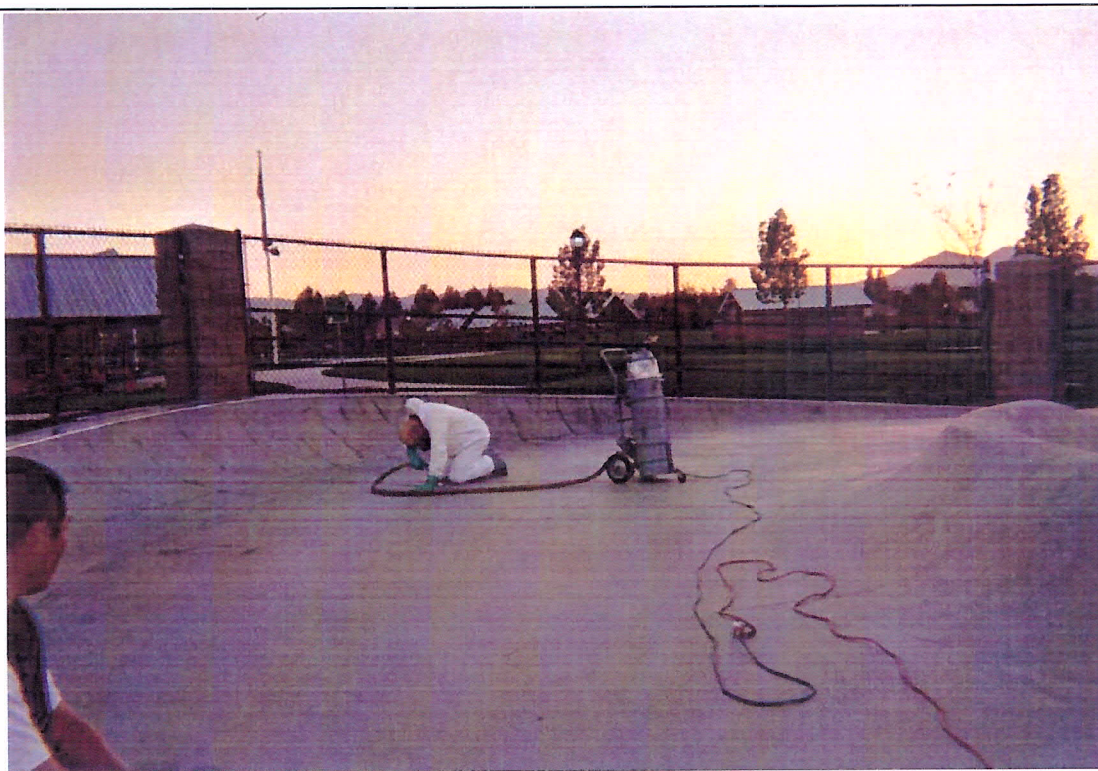
Photo No.
5

Contra Costa County
Hazmat Team member
vacuuming impacted
areas.

A mercury vacuum was used to attempt to remove residual mercury within the seams and cracks of the cement. Three attempts were made to remove contamination. After each vacuum attempt, mercury vapor concentrations were sampled utilizing the Lumex Mercury Vapor Monitor. mercury vapor readings were taken at both ground level and at 2 feet above ground surface—the estimated breathing zone for children. Mercury vapor concentrations at ground level showed little decrease, persisting at ranges of 500 to 5,000 ng/m³. Breathing zone maximum vapor levels were recorded to be 200 ng/m³. To further mitigate the vapors at ground level, Team 9 and County Hazmat members sprinkled Hg-Absorb within the seams of the cement; wet it in accordance with the manufacturer's directions; and allowed it to sit for approximately 15 minutes. Breathing zone vapor concentrations decreased to less than 10 ng/m³ in all areas. The Hg-Absorb was vacuumed, and the areas were re-sampled. Elevated vapor concentration readings persisted at ground level. In an attempt to further mitigate mercury vapor concentrations, sealant was applied to the cracks. At 2030, officials left the scene to allow the sealant to dry overnight.

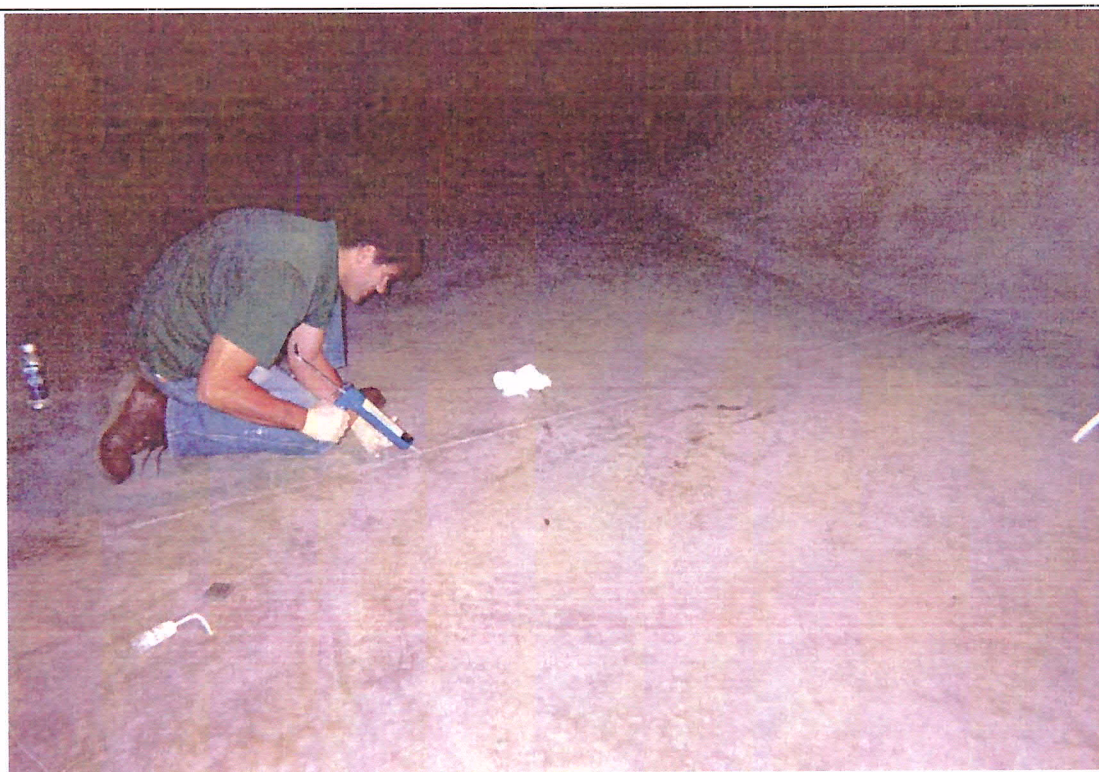
Photo No.
6

Brentwood Park Staff
performing sealing to
suppress remaining
vapors..

additional cleanup within the seams and cracks of the impacted portion of the skatepark. Following additional clean up activities, the seams in the area were sealed with an Epoxy sealant. It was concluded by the OSC Suter and County Heath that risk to human health due to mercury vapor was minimal.
